**Re: Sandia Marble, Unpermitted Discharge/MSGP; SIC 3281; NPDES Compliance Evaluation Inspection; NPDES #NMU001929; January 12, 2017**

## NPDES Compliance Inspection Report

**Sandia Marble**  
**Compliance Evaluation Inspection**  
**NPDES Permit No. NMU001929**  
**January 12, 2017**  
**Further Explanations**

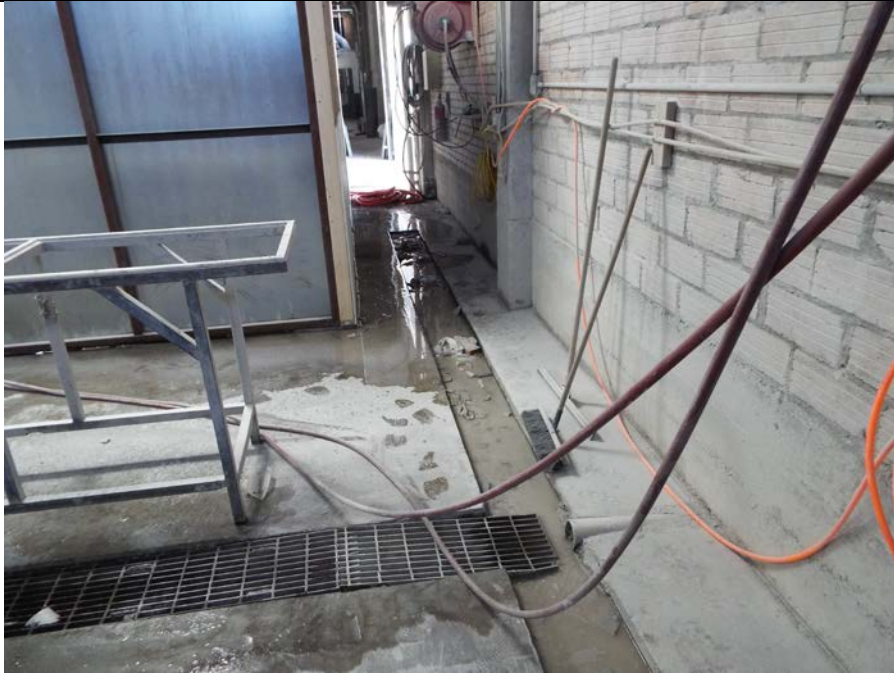
**NMED/SWQB  
Official Photograph Log  
Photo # 1**

Photographer: Daniel Valenta	Date: 1/12/17	Time: 2:40pm
City/County: Albuquerque/Bernalillo		State: New Mexico
Location: Sandia Marble		
Subject: Water from cutting stone and floor trench system to drain pipe

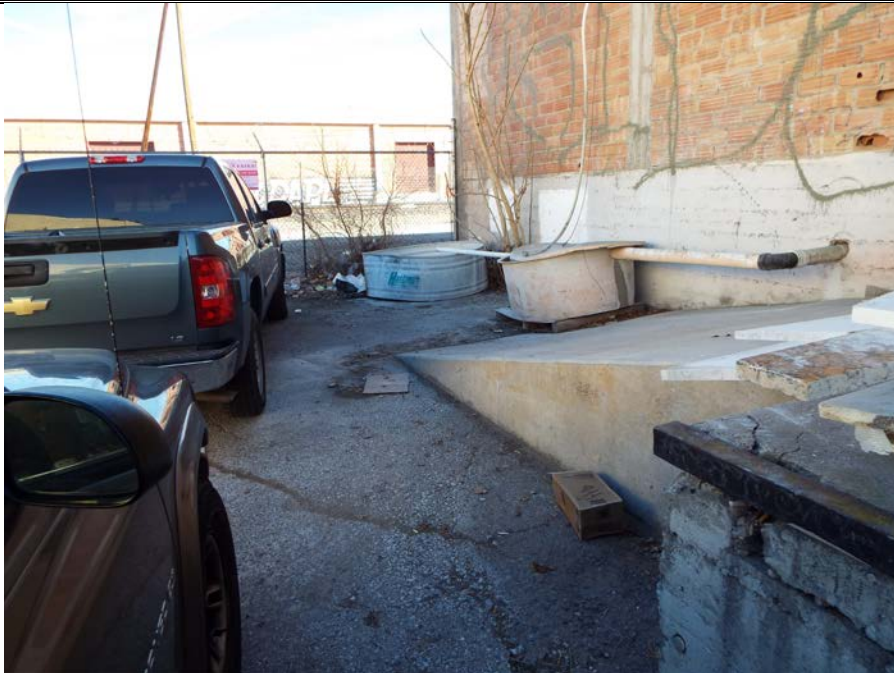
**NMED/SWQB  
Official Photograph Log  
Photo # 2**

1. The facility had a system of tanks on the outside of the building to settle out cutting water and recycle it back into the building. There was staining on the asphalt indicating that the system sometimes overflows towards the street and the city storm sewer system when it freezes or otherwise malfunctions. The system also has a drainline to the railroad right of way and was discharging water at the time of the inspection (Photos 1-2). The facility estimated they use about 10 gallons of water a day through this system. This facility does not have NPDES permit coverage for the discharge of process water from stone cutting operations.

Photographer: Daniel Valenta	Date: 1/12/17	Time: 2:50 pm
City/County: Albuquerque/Bernalillo	State: New Mexico	
Location: Sandia Marble		
Subject: recycle/settling basins, some white staining on pavement from overflow running towards street.

On 1/13/17 the facility sent photos to confirm they had removed the system and halted the discharge (attachment 1).

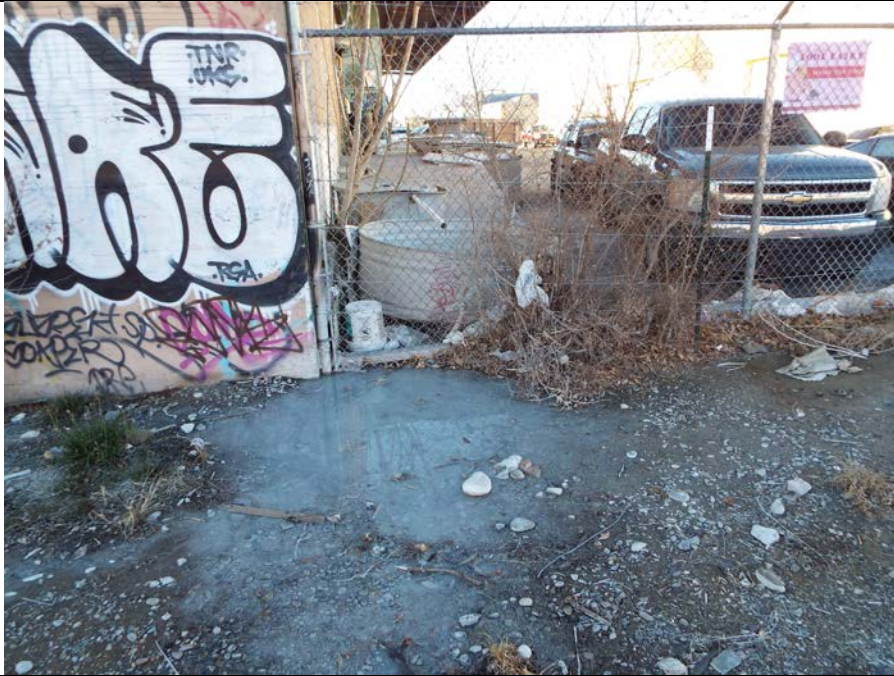
**NMED/SWQB  
Official Photograph Log  
Photo # 3**

Photographer: Daniel Valenta	Date: 1/12/17	Time: 2:58 pm
City/County: Albuquerque/Bernalillo		State: New Mexico
Location: Sandia Marble		
Subject: discharge pipe to railroad right of way

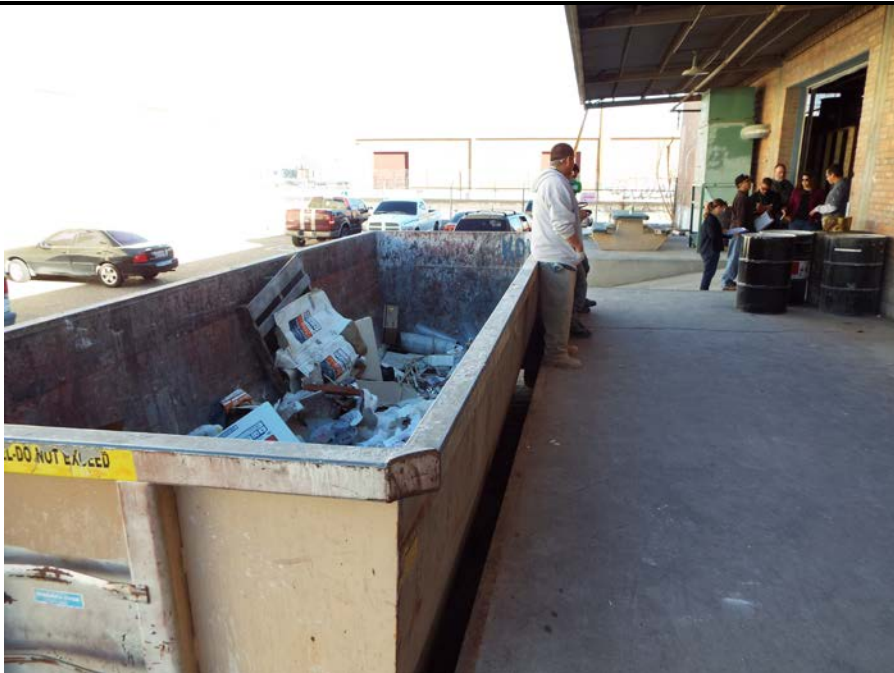
**NMED/SWQB  
Official Photograph Log  
Photo # 4**

2. The facility activities fall under MSGP Sector E, Glass, Clay, Cement, Concrete, and Gypsum Products (which includes cut stone and stone products). The facility had one uncovered dumpster exposed to stormwater. In addition, the facility had an outdoor system of tanks to settle out cutting water and recycle it back into the building (as stated above it was removed on 1/13/17). All other activities and materials at the site were indoors or protected from exposure to stormwater.

Photographer: Daniel Valenta	Date: 1/12/17	Time: 2:51pm
City/County: Albuquerque/Bernalillo	State: New Mexico	
Location: Sandia Marble		
Subject: Dumpster exposed to stormwater

The facility was not aware of the need for coverage under the MSGP. On 2/6/17 Ms. Maes sent a follow up email to the inspector stating they had obtained their No Exposure Certification (Permit # NMNOE3458).

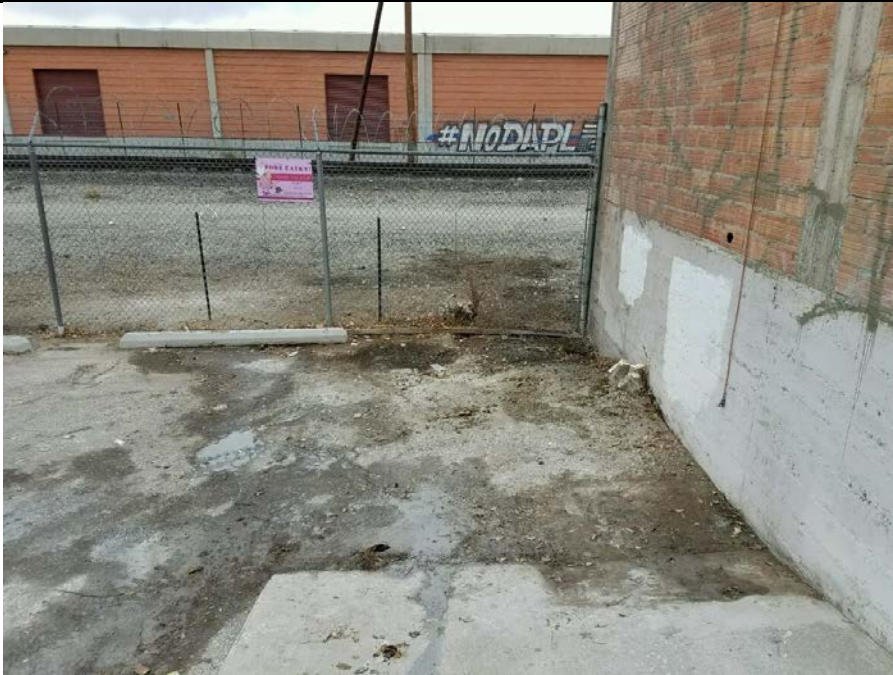
# Attachment 1

Photographer: Sandia Marble	Date: Approx 1/13/17	
City/County: Albuquerque/Bernalillo		State: New Mexico
Location: Sandia Marble		
Subject: documentation that tanks have been removed

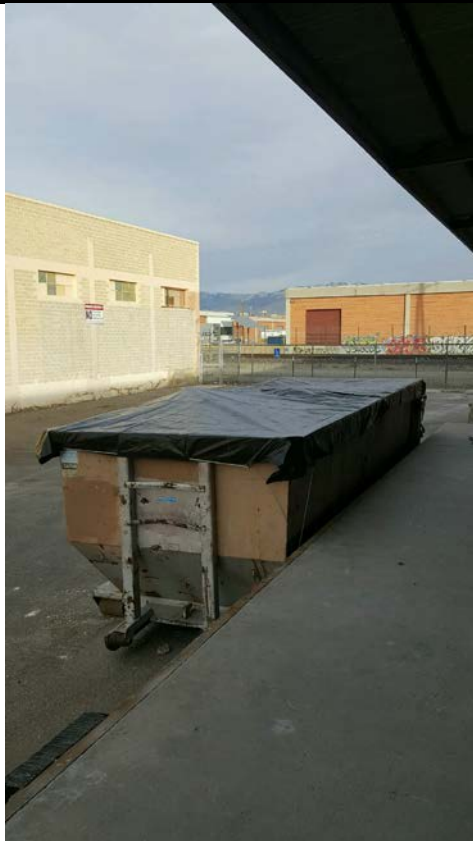
Photographer: Sandia Marble	Date: Approx 2/6/17	
City/County: Albuquerque/Bernalillo	State: New Mexico	
Location: Sandia Marble		
Subject: documentation that dumpster has been covered
